Structural Design of Dam Sluice Gate Walkway Slabs: Retrofit and Replacement Options

I. Project Description

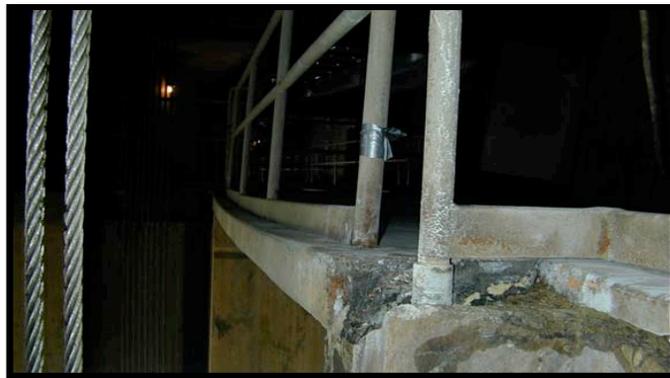
Figure 3 presents a photograph of one of the existing walkway slabs. Deflections were measured to be as large as 2.5 inches. During previous maintenance activities, these slabs were overloaded and permanently damaged by service crews. Although crews are now more conscientious of the load capacities, the past overloading excessively deflected the slabs posing a life-safety hazard for utility workers. Consequently, the walkways need to be strengthened or replaced.

Figure 3. Existing slab deflection (measured at site visit as up to 2.5 inches)

The steel retrofit was presented as an economical alternative to a full replacement and was expected to increase the load capacity of the existing slabs to that specified by the sponsor while limiting further deflections. The retrofit involves installing beams under the slab to reduce the span length and thus the deflection.

Rebar corrosion in the existing slabs is a concern and the retrofit design assumes 100% strength (non-corroded) of 40 ksi rebar. Therefore, the design requires that the existing rebar be checked using a corrosion analysis instrument (Proceq Canin). If the rebar is not corroded, the retrofit may be carried out. If corrosion is found, the design strength of the slabs should be reduced, or if corrosion is extensive, it may be necessary to pursue the full replacement option. It is also essential to seal the cracks in the bottom of the slabs so that water will not penetrate into the cracks, consequently, into the rebar.
