Multidisciplinary Evaluation and Rehabilitation Design of Sacred Heart Catholic Church

ABSTRACT

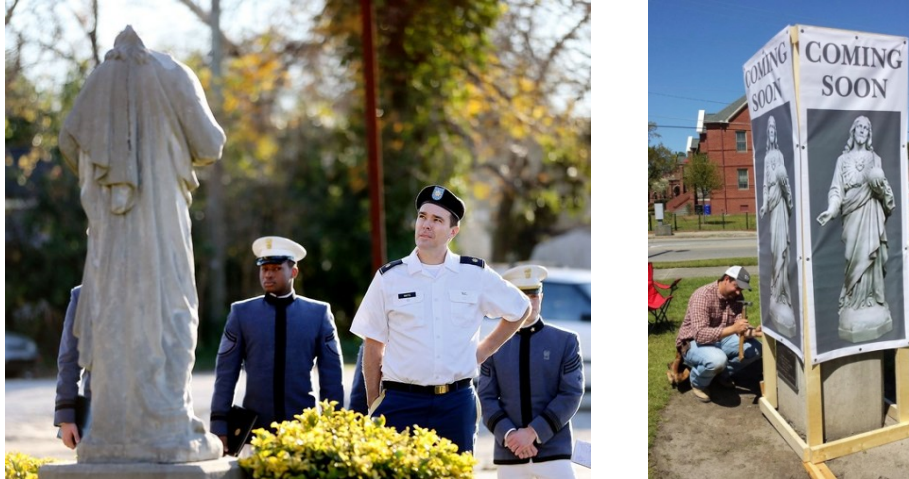
Figure 2. Demolished statue at church (left; provided by local newspaper) and student constructing student-designed statue cover for use until new statue is made (right). Students raised funds needed to pay deductibles for both demolished statues at the church.

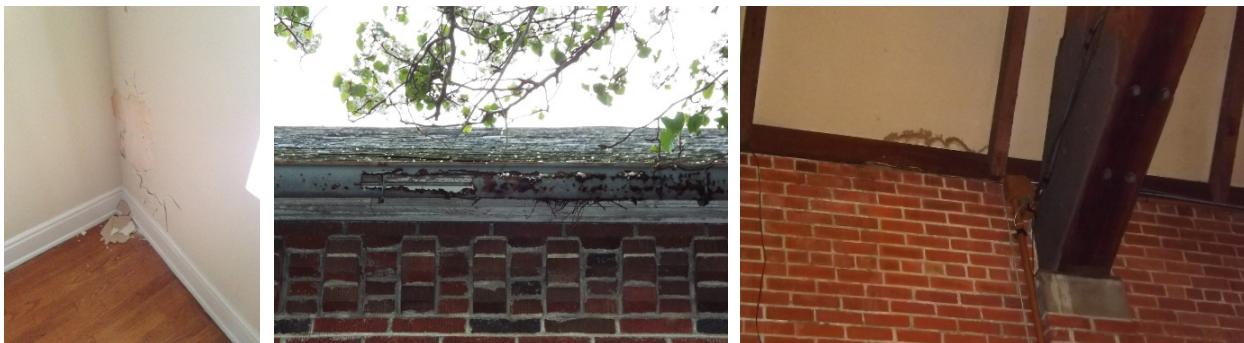
Figure 3. Examples of church deterioration, including peeling paint caused by excessive water on masonry (left) caused by leaky gutter (middle), as well as evidence of leaky roof (right).

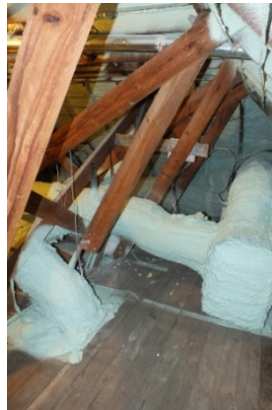
Figure 5. Wood brace cut for duct passage. Structural engineer made a quick calculation in front of the students and determined that the brace was redundant and not needed anyway.

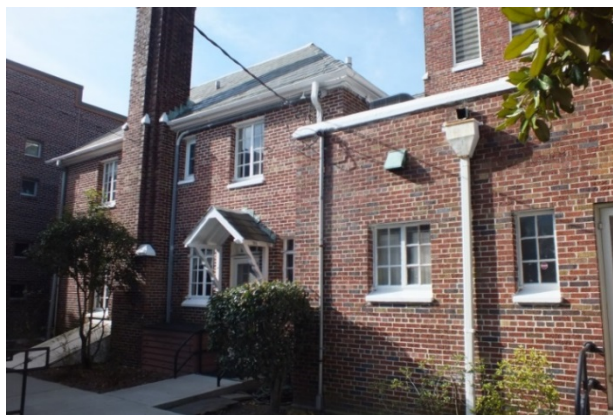
Figure 6. Back of church structure. Unbraced chimney near the exit is a life safety issue due to high seismicity which was not considered during original construction in 1939.
