# Seismic Assessment and Retrofit of a County Pump Station

A pump station, owned and operated by a county, is part of a flood control system for three surrounding densely populated cities. The pump station, comprising of a steel pumphouse and a reinforced concrete dam, was built in 1960's prior to seismic provisions were in place.

The county requested one of our capstone teams to perform a seismic assessment of, i) the two structures, ii) non structural elements within the pumphouse, and iii) the retaining wall which is part of the fish ladder within the system, and provide retrofit recommendations for any identified deficiencies.

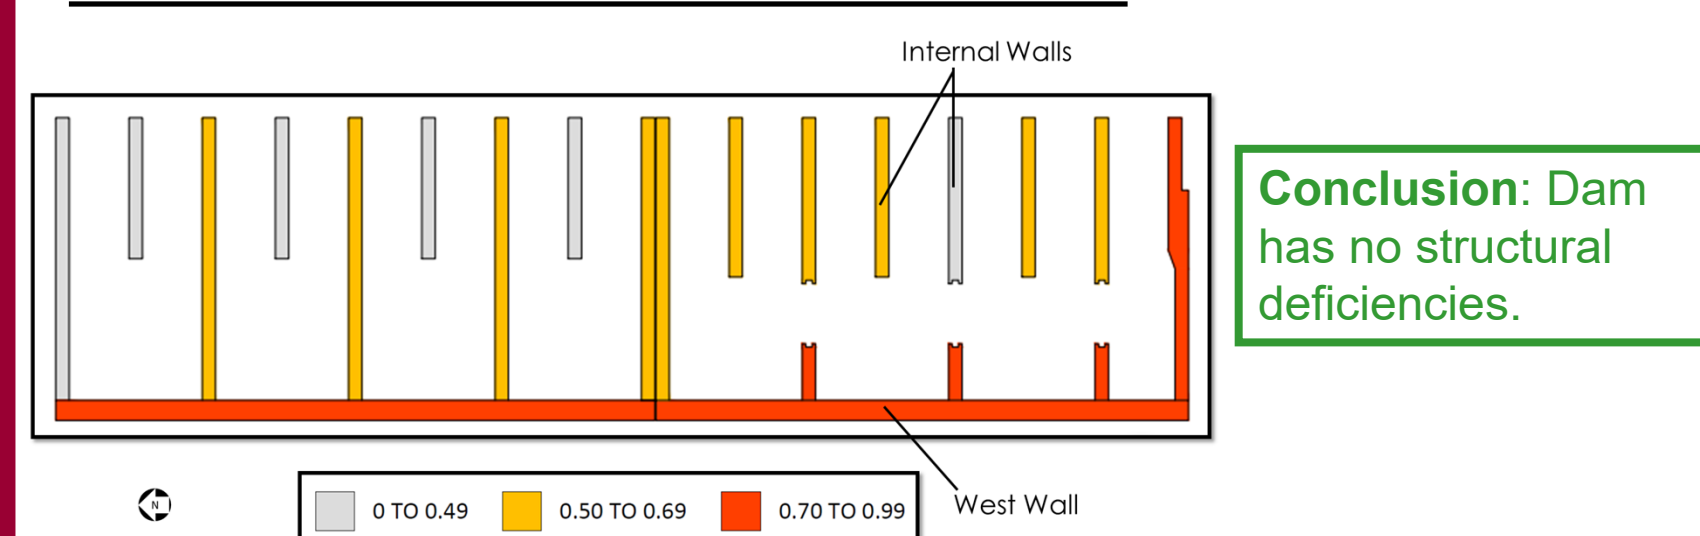
#### Plan View of Dam with D/C Ratios of walls

- $D/C$  ratio is  $< 1$ , structural element satisfactory
- $D/C$  ratio  $> 1$ , retrofit needed

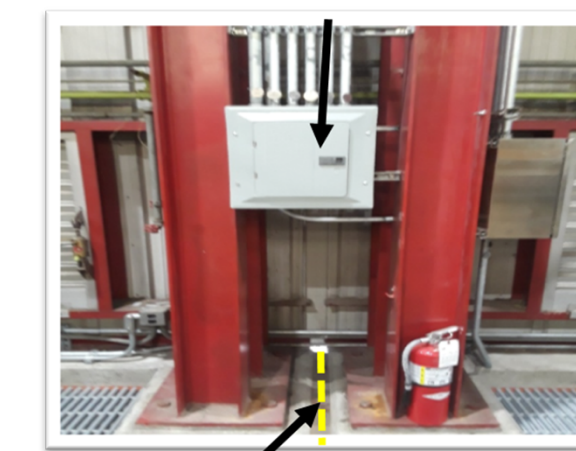
Electrical unit crosses Extension Joint

Extension Joint

- Recommendation: Relocate electrical unit to one side of building.

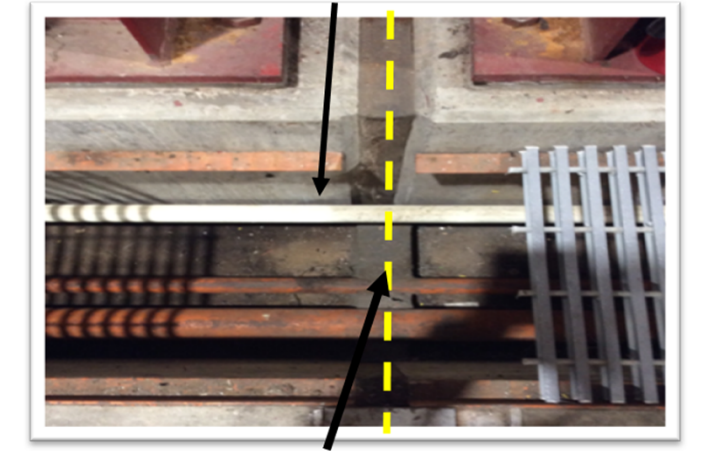
Fuel line, Conduits and Pipes cross Extension Joint

Extension Joint

- Recommendation: Fit flexible coupling where pipes and conduits cross extension joint

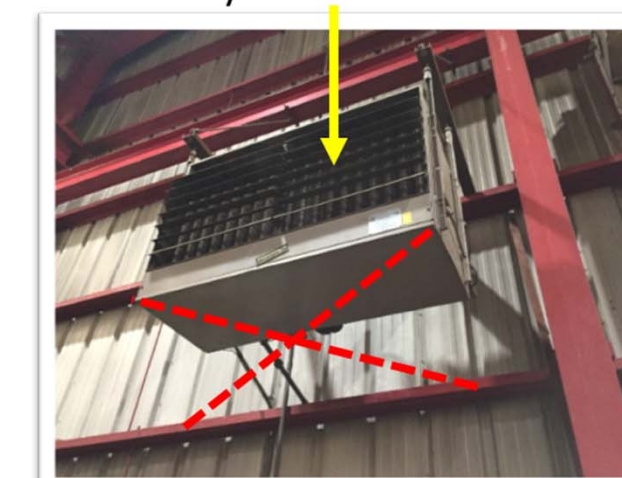
Laterally Unbraced HVAC Unit

- Recommendation: Install lateral bracing to resist seismic forces

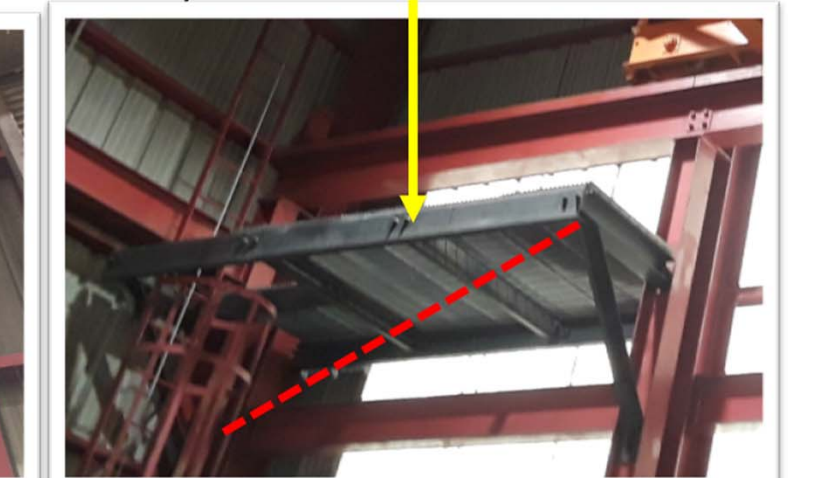
Laterally Unbraced Crane Access Platform

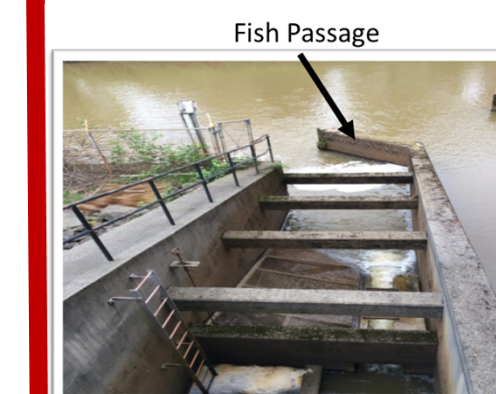
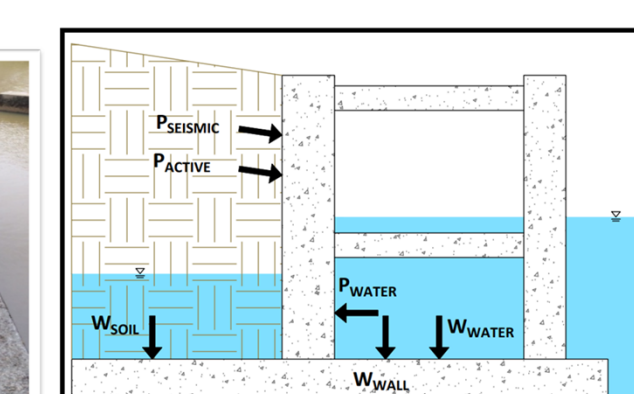
Computed factors of safety against common modes of failure.

- Conclusion: Wall stable in the event of design earthquake

Factors of Safety against overturning 1.7; sliding 1.14; bearing 1.32

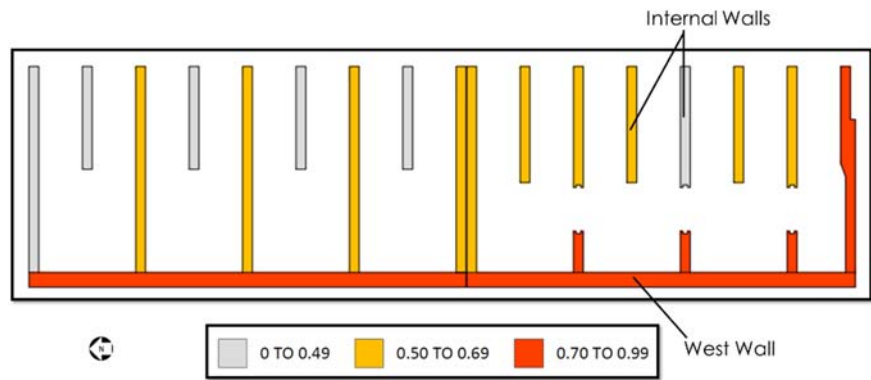
Figure 3. Plan View of Dam Walls and their Corresponding Demand to Capacity Ratios

For the dam structure, the team computed the D/C ratios of the various walls within the dam. The results are shown in Figure 3. All walls have D/C ratios of less than one, indicating they are compliant. Thus, the team concluded that there are no deficiencies in the dam.

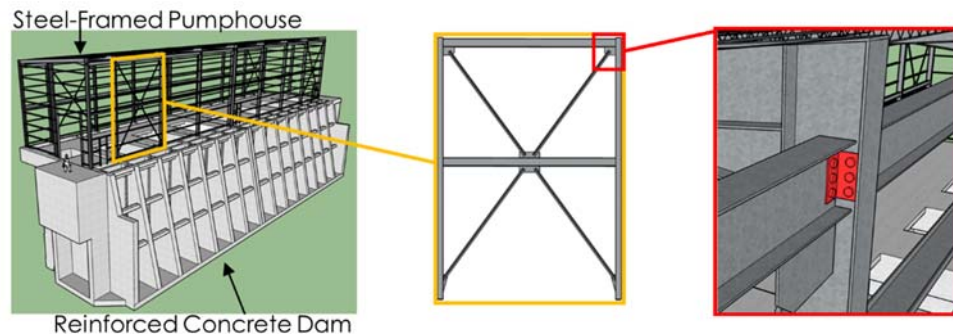
A double angle connection that fastens the north-south beams to the columns was the only potential deficiency identified for the pumphouse. This potential deficiency is shown in red in

Figure 4. Deficient Double Angle Beam to Column Connection (shown in red)

Figure 4. Because the thickness of the angle in the connection was not documented in the structural

drawings provided to the team by the county, and the team could not safely access this connection on-site, the team assumed an angle thickness of 1/4" in its analysis. There is a total of 32 double angle connections within the pumphouse structure as shown in red in Figure 5.

For the pumphouse column to beam connection deficiency shown in Figures 4 and 5, the team recommended that the existing angle thicknesses be first measured on site. If the angle is 3/8" or thicker, the member is adequate and no retrofit is needed. But if the thickness is less than 3/8", the actual thickness should be compared to the minimum thickness required at each double angle connection location and inadequate angles should be replaced.

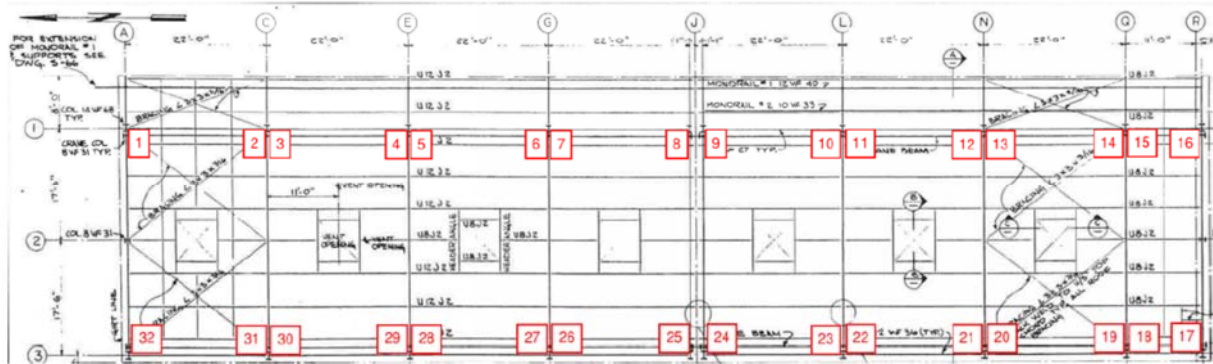
Figure 5. Plan View of Pumphouse showing Locations of Potentially Deficient Double Angle Connections (labeled in red)

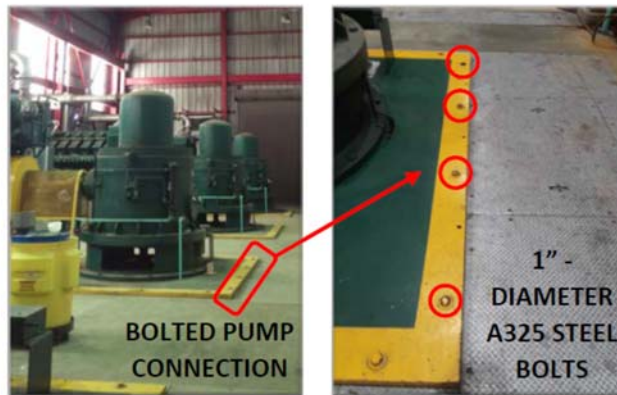
The bolted connection of one of the largest pumps (P6 in Figure 2-bottom) onto the pumphouse floor was found to be the most critical non-structural member due to the large seismic mass and eccentricity between the pump and the bolted connection. The team checked the A325 steel bolt connections shown in Figure 6 and found them to be adequate with a D/C ratio of 0.02.

Figure 6. Bolted Connection between Pump Equipment and Pumphouse Floor

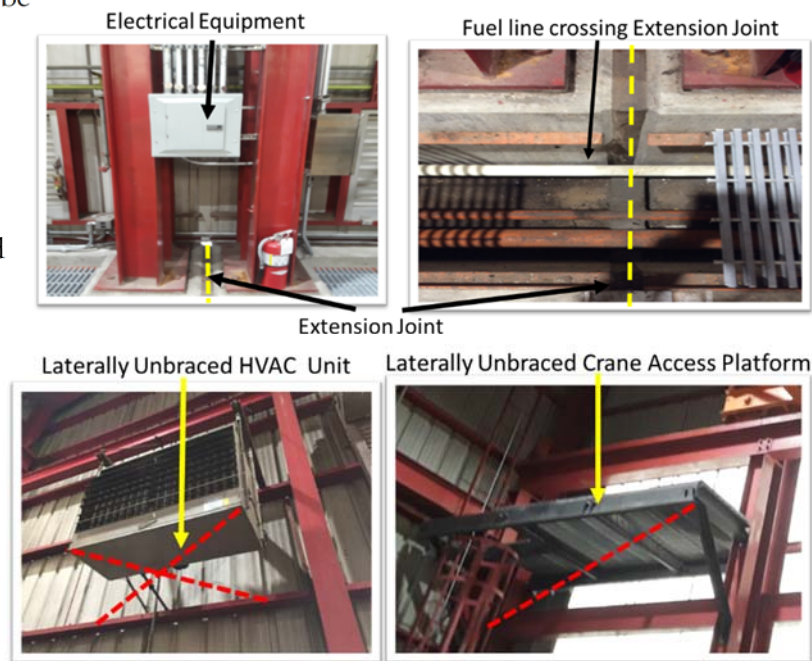
Nevertheless, Tier 1 screening revealed non-compliance of various non-structural elements within the pumphouse: a) equipment were crossing the expansion joint without flexible coupling, 2) some equipment were not laterally braced. The team recommended retrofit options for the non-structural

Figure 7. Retrofit Recommendation of Non- Structural Elements within Pumphouse (top: electrical equipment (left) and fuel lines (right) cross extension joint; bottom: unbraced HVAC unit (left) and crane access platform (right))

elements within the pump house. These are presented in Figure 7; any electrical equipment that is mounted across expansion joint be relocated to one side of the building (top left); all fuel lines and conduits be fitted with flexible couplings (top right); heating, ventilation and air-conditioning (HVAC) units and crane access platforms be braced against lateral motion, (bottom left and right, respectively).

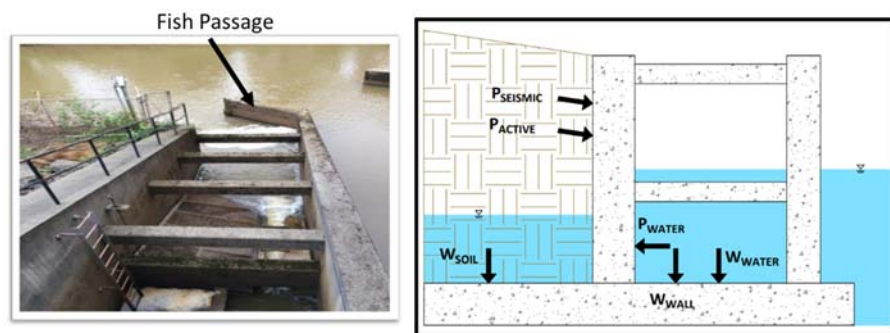
As mentioned earlier, the county requested that the team perform a stability analysis of the retaining wall forming the fish ladder. Figure 8 shows a closeup view of the fish ladder at the site. It consists of a counterfort retaining wall with a sloping backfill and strut bracing.

The team performed stability analysis of the retaining wall under loading imposed by the design earthquake. The factors of safety against the most common modes of failure of a retaining wall, namely overturning, sliding and bearing capacity failure, were computed. These factors of safety were found to be 1.7, 1.14, and 1.32 (which correspond to D/C ratios of 0.58, 0.88, and 0.76), respectively. The county deemed these values satisfactory.

Figure 8. Picture of Fish Passage (left) and Idealization for Stability Analysis of Retaining Wall (right)
