# DESIGN AND CONSTRUCTION OF A RELIABLE DRINKING WATER SYSTEM FOR AN ORPHANAGE IN CENTRAL AMERICA

#### DESIGN AND CONSTRUCTION OF A RELIABLE DRINKING WATER SYSTEM FOR AN ORPHANAGE IN CENTRAL AMERICA Abstract

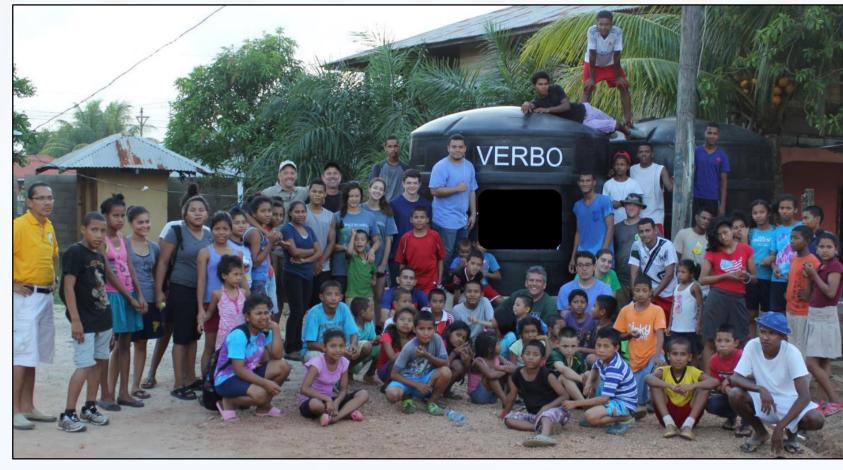
Students collected and analyzed water samples onsite. Samples were taken for turbidity, bacteria, and pH. Students also worked with a professional engineer from the local Public Works Department to design a low maintenance, reliable filtration and ultraviolet disinfection water treatment system. The system is able to treat 30 gpm. Students also trained the orphanage staff how to perform O&M.

Working alongside professional engineers, the student organization implemented an Ultra Violet (UV) Disinfection System capable of processing the water demand for approximately 150 orphaned children. In addition to the UV system, a new, pressurized, looped water distribution network was installed, which encompassed the existing facilities and replaced the broken, cracked, and moldy infrastructure.

cabinet in protecting the UV disinfection equipment and filters, the location of the unit was strategically placed behind the tank pad. The students designed the control panel to be of a user-friendly height and to take up as little space as possible to function. To limit the required space of the panel, a trap door was included to allow the UV light to be replaced annually, as recommended

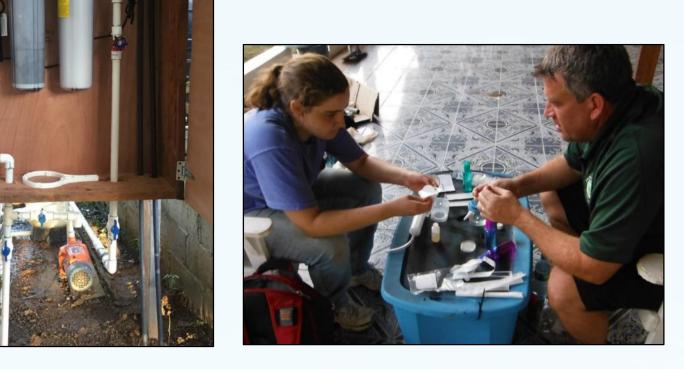
Prior to traveling, students developed a Plan Of Action and Milestone (POAM). The POAM included, student assignments, materials management, procurement plan, and a detailed critical path project schedule. Every night during construction, the Project Manager (a student) would hold a meeting to review the critical path. Due to optimal construction **Control Systems Engineering:** The orphanage needed a system that was fully automatic. Students developed a process and control diagram (P&ID). This P&ID became the road map during construction. Shown above, is a professional engineer and one of the students calibrating a pressure switch during construction.

*Electrical Engineering:* The students worked with a professional electrical engineer to design and install the control panel that powers the distribution and switch components. A pressure switch was installed and set to turn on the booster pump when water pressure is below 20 psi and to turn it off when the pressure exceeds 40 psi. A float switch was installed in the interconnected tanks so that when the tanks are filled, the switch turns the well pump off. Once the water elevation goes below a certain point, the float switch turns on the well pump to begin filling the tanks once more. All of the electrical components were installed underground or a minimum of 12 ft above ground in a manner to prevent the children from accidental contact with any wiring, both ensuring their personal safety and preventing system tampering.

*Mechanical Engineering:* Under the guidance of licensed engineers, an appropriate booster pump size of 1.5 HP was selected and the pressure switch was calibrated to a range between 20-40 psi.
