WATER FOR MASAIRA

REHABILITATION OF A MAN-MADE IRRIGATION CANAL

Maji for Masaera

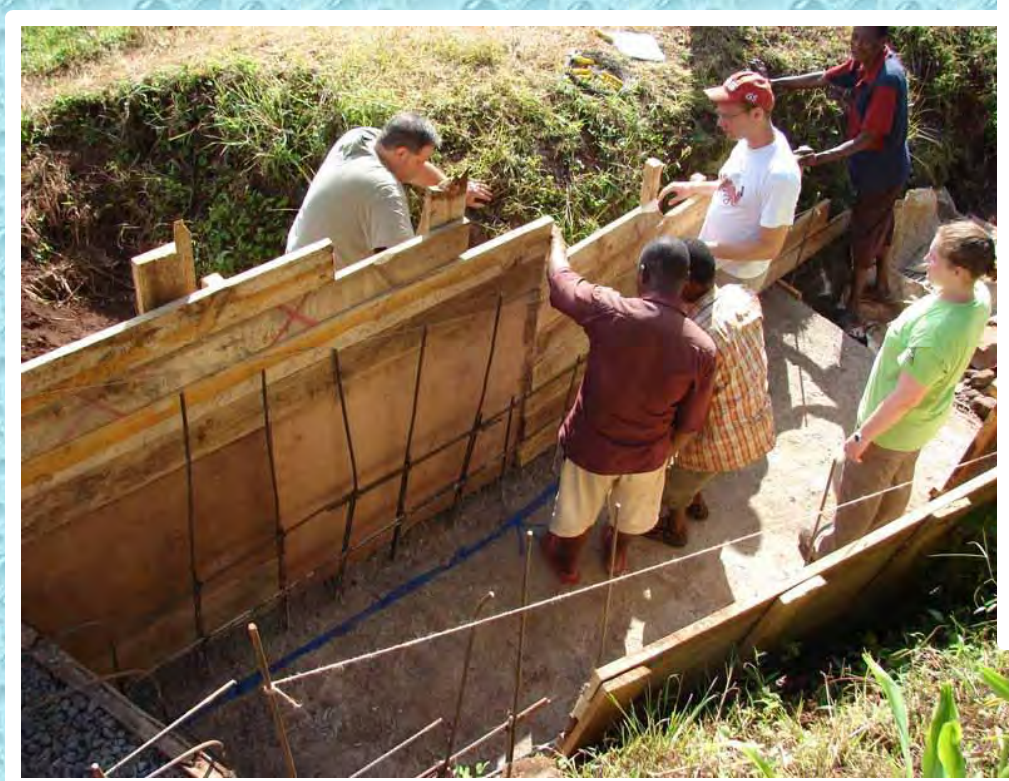
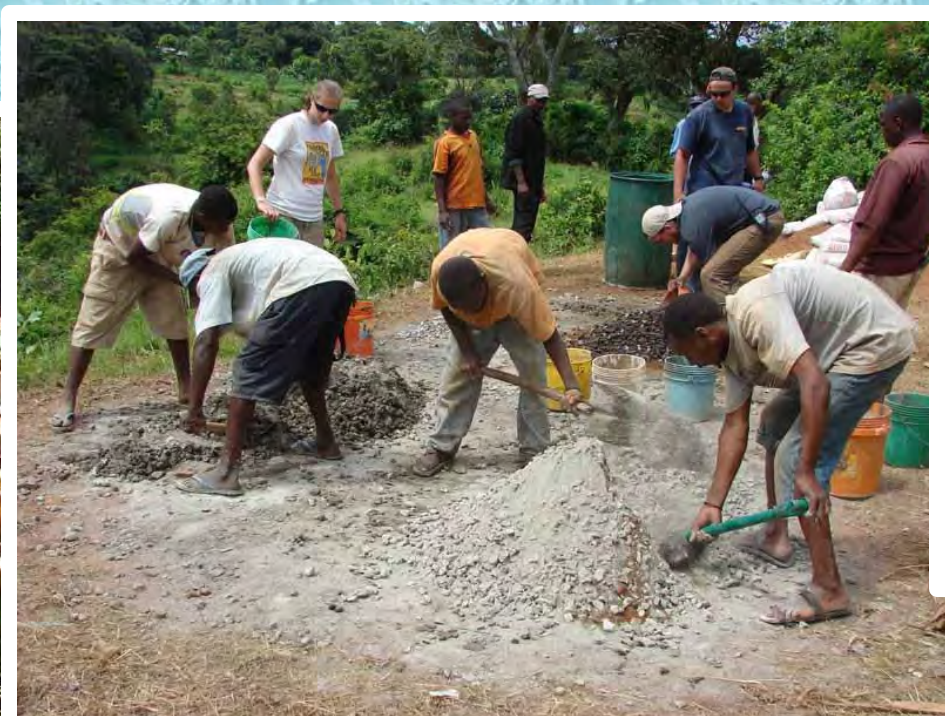
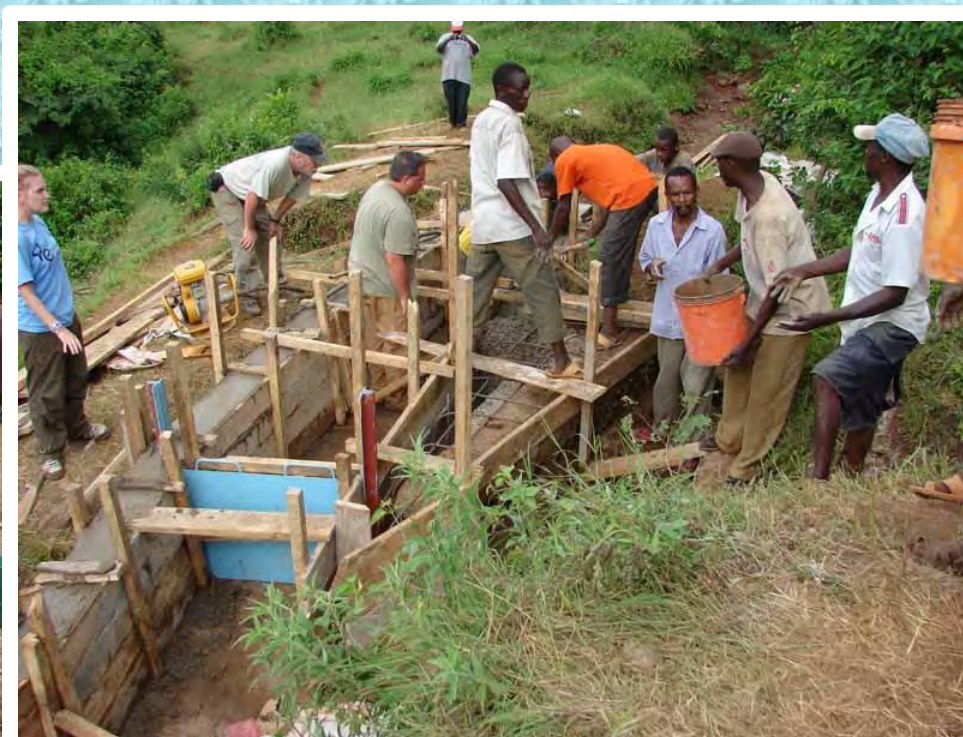
Training villagers in formwork (left), concrete mixing (middle), and concrete placement (top right), sample instructions for maintenance manual (bottom right).

Solution: Train local villagers, leave detailed instructions in a Canal Maintenance, Operations, and Repair Manual, and sign a Memorandum of Understanding with local Water Council.

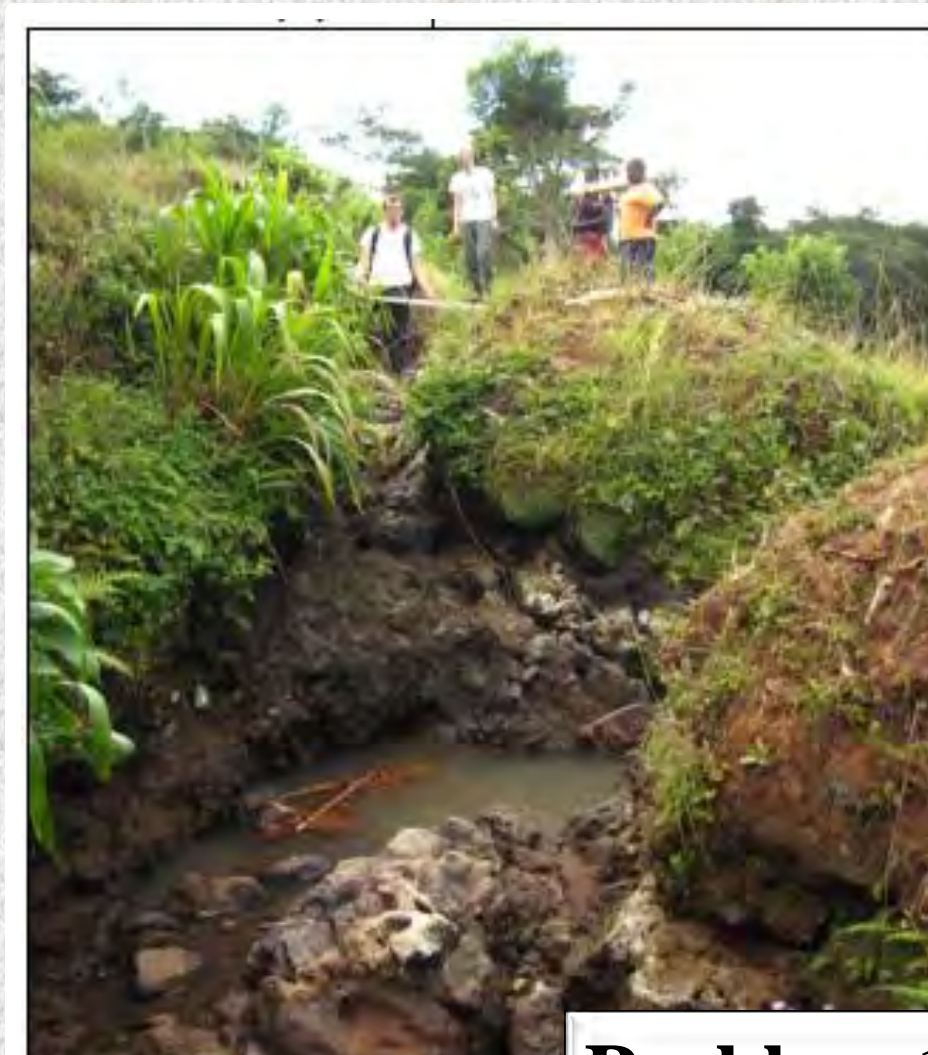
Junction 1 Repair

Design sketch (top) and drawing of implemented design (bottom).

Dropbox Design: Water approaches the dropbox in a 14 ft concrete channel approach. At the end, there is a 3 ft drop onto a 12 ft long concrete slab, such that, once the water falls 7 ft into the concrete box, it is contained by the wing walls to prevent continued erosion of the banks. Channel and slab walls contain all the water, and a sluice gate installed at the head of the left branch helps control the flow of water in the two canal branches.

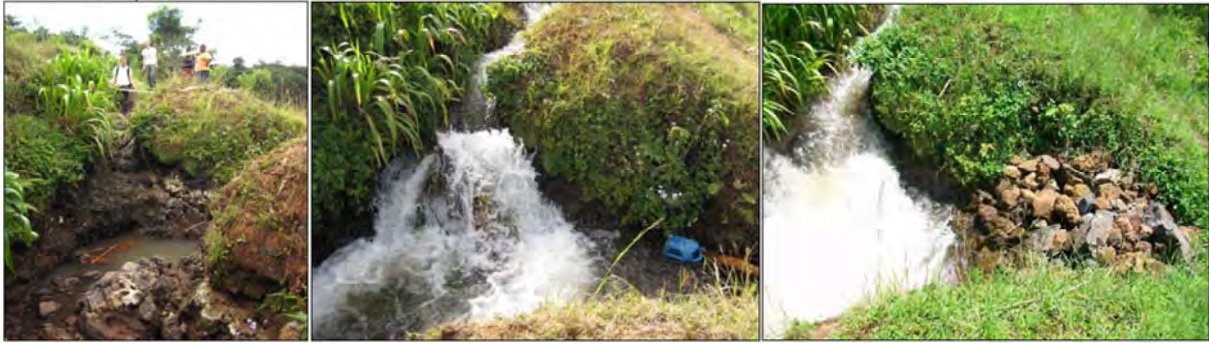
Building on their extensive assessments, analyses (including water velocity measurements, a soil survey, stream modeling using the River Analysis System developed by the Hydrologic Engineering Center in Davis, California (HEC-RAS), and more) and emergency repair work from previous trips, this past May, the student team concentrated on repairing Junction 1 (see Figure 1). Figure 2 shows how a significant change in elevation results in a waterfall of approximately seven feet down the left branch of the junction. This drastic elevation change increases water velocity, promoting quickly expanding erosion, which had already resulted in a large basin on the downhill side of the canal and increased the breach risk. A mechanism to reduce

the water flow rate was severely needed (Fig. 2).

Figure 2: Junction 1 dry showing canal bed erosion (left), then with water flow showing runoff to the right (middle), and with emergency fix (rocks) implemented in 2010 (right).

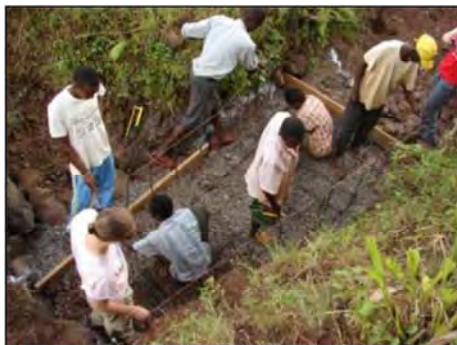
Figure 4: Villagers and EWB students tie the rebar for the drop box.

The Junction 1 Team and their local collaborators spent the first work day excavating soil and stone, grading and backfilling the drop-box floor, and forming the drop-box slab. They also cut and assembled reinforcing steel structures for the drop box. On the second work day, they finished the rebar for the wall and slab tie-ins, dug toe walls, and installed the rebar properly. In addition, they completed the formwork for the drop box, placed the concrete, and finished the slab. The following day, the team worked on the rebar cage for the drop box and the channel, constructed the exterior base formwork, and also backfilled the channel with aggregate. On their fourth work day,

they finished the rebar cage for the channel slab and the formwork for the drop-box back wall. They also placed concrete for the back wall and in the floor of the channel, so that all walls of the drop box were finished the following day, which included finishing the formwork and placing the concrete. The next day, the formwork for the channel walls at the beginning of
