Load Rating and Repair Options for Bridge Connecting Dam and Intake Structure

LOAD RATING AND REPAIR OPTIONS FOR BRIDGE CONNECTING DAM AND INTAKE STRUCTURE

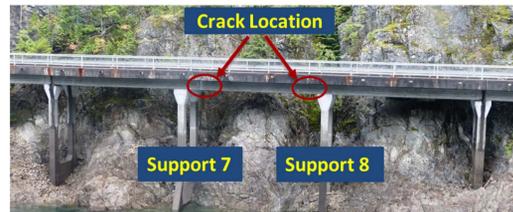
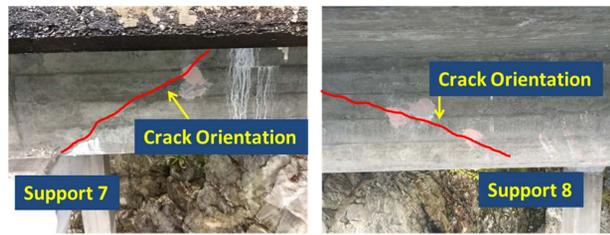
Figure 2. Orientation of Cracks in Span IV at a) Support 7, b) Support 8

The client first observed the cracks in section IV during a routine inspection in 2004. Since then, the cracks have grown over time and consequently the client has limited the movement of heavy machinery onto the bridge until a complete load rating is conducted. Figure 2 shows the cracks observed close to supports 7 and 8.

A local hydroelectric power utility company noticed cracks in a bridge connecting the dam and its intake structure. The company requested one of our civil engineering capstone teams to perform load rating of the bridge, and recommend retrofit options to control further cracking enabling safe use of the bridge by maintenance vehicles.

Project Description: A local hydroelectric power utility company found diagonal cracks in a concrete bridge connecting the dam to its intake structure. The utility company requested our senior capstone team to perform a load rating of the bridge and recommend retrofit options to ensure safe operation of the maintenance vehicles using the bridge.
