# Restoration and Replacement Options for a Utility Company Bridge

## **Restoration and Replacement Options for a Utility Company Power House Bridge**

## RESTORATION AND REPLACEMENT OPTIONS FOR A UTILITY COMPANY POWERHOUSE BRIDGE

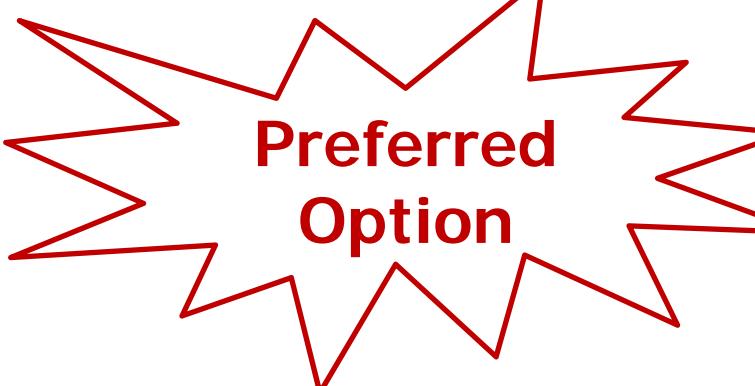
Description	Cost (\$)
Demolition	37,000
Construction	87,000
Materials	106,000
Fabrication	40,000
Transportation	12,000
Loss of Revenue	18,000
<b>Total</b>	<b>300,000</b>

The team recommended a gantry crane system (shown in the poster) for the demolition and replacement of the bridge. This system will be comprised of a trolley and hoist connected to a simple frame; the frame will move on motorized wheels and run longitudinally along the bridge on fixed tracks. The gantry crane has the advantage of keeping all the construction work below 14 ft thus eliminating interruption of Powerhouse operations. The track and trolley system will be extended beyond the bridge footprint facilitating the loading and unloading of materials onto trailer trucks. Following that the team provided a detailed demolition and construction sequence for the bridge.

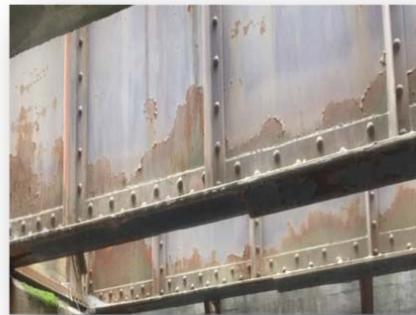
**Figure 2. a) Cross Section of Existing Bridge; b) Plate Girders with Flaking Paint**

Figure 2 shows the cross sectional view of the existing bridge. It is a single lane, two-span structure crossing the outflow of the Powerhouse. The bridge has an approximate total span of 111 ft and a roadway width of 14 ft. The driving surface of the bridge consists of steel grate decking. The decking is supported by cross beams and the cross beams are in turn supported by 6 ft deep plate girders. The plate girders rest on bridge abutment at one end and the center support at the other.

Lead paint on the steel members (Figure 2b) is flaking off into the Powerhouse outflow which eventually feeds into a nearby river. The utility company is concerned about the environmental impact the lead contamination could have as the river and its surrounding is home to salmon, bald eagles and other species.

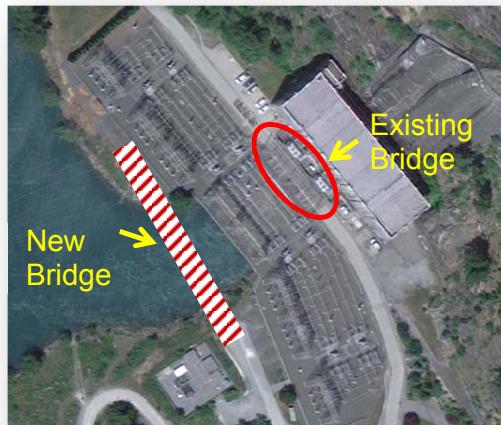
**Figure 5. Replacement and Existing Bridge Locations**

The existing bridge will be restored as described under option 1 and will be used by the Company personnel. All other traffic will be rerouted via a new bridge located away from the Powerhouse as shown in Figure 5. Relocation of the bridge alleviates the security concerns the Company has had due to the existing bridge's close proximity to the power operations.

The proposed bridge is a 140' long, 17' wide single span structure. The driving surface will be 14' wide with 1/5' wide guard rails on each side of the road. The bridge decking will consist of 10" concrete slab. The decking will be supported by three A572 steel plate girders 4' center to center spacing with 90"x3 3/4" webs and 16"x1 1/4" flanges. The bridge foundations will consist of 10'x15'x2' spread footings at the approaches.
