Structural Design of Dam Sluice Gate Walkway Slabs: Retrofit and Replacement Options

I. Project Description

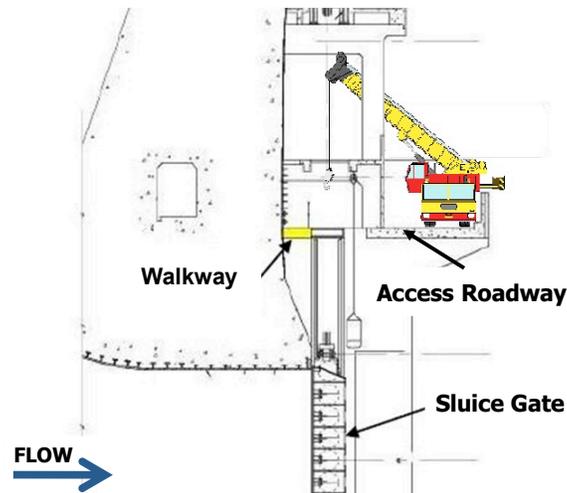
Figure 4. Typical Cross Section through Sluice Gate

Maintenance Walkways Access - The walkways are served by a narrow roadway on the dam's face that is accessible only through a tunnel in the dam's west abutment. The tight clearances and the roadway's load capacity limit the use of heavy construction equipment such as concrete

trucks, concrete pumps, and the utility's crane. Figure 4 shows a typical cross section through the sluice gates. Crane access is further limited by overhead roof structures that were constructed after the installation of the original walkway. Demolition and construction plans needed to account for these restrictions.

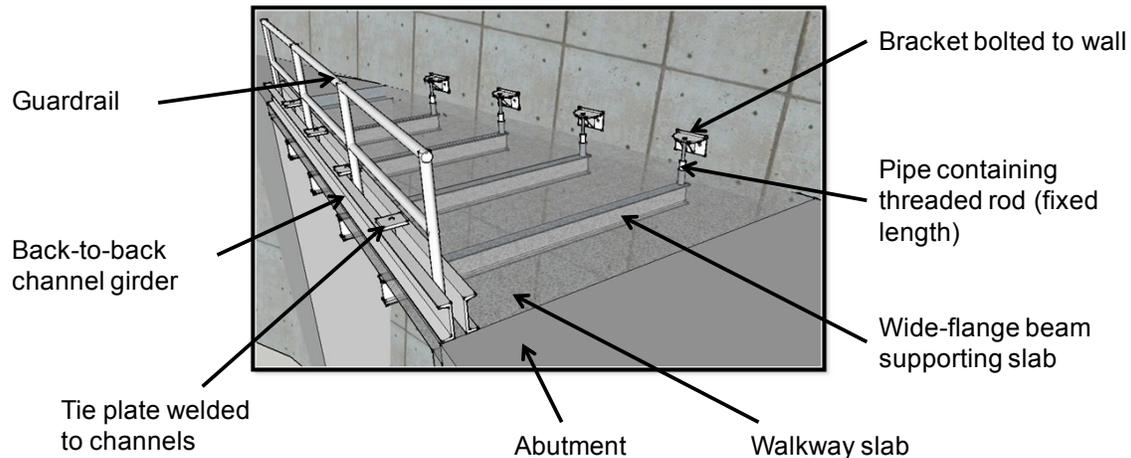
Figure 5. Completed Steel Retrofit

Figure 5 shows the steel retrofit option. Four wide-flange beams support the floor slab, satisfying the deflection requirements. The beam supports consist of a pipe welded to the top flange at each end of the beam with a threaded inlet. The pipe extends above the beam through a core hole in the slab and a threaded rod connects the pipe to the supporting element for the beam. One end of the beam is supported by a bracket bolted to the wall 12 inches above the slab. The other side does not have a wall to support connection brackets, so a girder extends across the slab perpendicular to the beam for support. The girder is as long as the slab and will transfer the load through the slab into the existing abutments. The girder consists of back-to-back channels spaced three inches apart with the existing guardrail between them. A $\frac{1}{4}$ inch plate is welded to the bottom of the channels and a one inch plate to the top of the channels. These members brace the channels together. The top plate has a $1\frac{1}{16}$ inch hole to accommodate the threaded rod and supports the pipe and beam.

Rebar corrosion in the existing slabs is a concern and the retrofit design assumes 100% strength (non-corroded) of 40 ksi rebar. Therefore, the design requires that the existing rebar be checked using a corrosion analysis instrument (Proceq Canin). If the rebar is not corroded, the retrofit may be carried out. If corrosion is found, the design strength of the slabs should be reduced, or if corrosion is extensive, it may be necessary to pursue the full replacement option. It is also essential to seal the cracks in the bottom of the slabs so that water will not penetrate into the cracks, consequently, into the rebar.

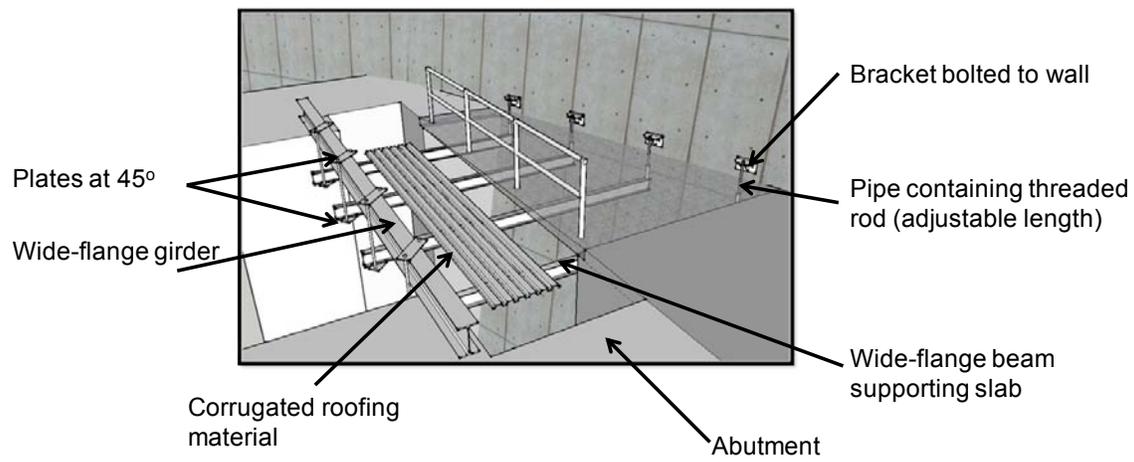
Figure 6. Completed Demolition Bracing System

Although the retrofit is the more sustainable and cost effective option, the project sponsor also requested a design for demolition and replacement of the existing slabs that guarantees a 50 year design life. Deteriorated slabs, or those damaged in the retrofit process, may be replaced using this design. Similar to the retrofit concept, demolition involves the installation of wide-flange beams under the slab. In this case, the beams serve to support the process of removal of the damaged slabs. Figure 6 shows the demolition bracing system.

The supporting beams connect to the dam wall in the same manner as described in the retrofit option. In the downstream end, a wide-flange girder rests between the abutments. The beams connect to the girder with plates on the top and bottom flanges oriented at 45°, as shown Figure 6, using threaded rods.
