Multidisciplinary Evaluation and Rehabilitation Design of Sacred Heart Catholic Church

ABSTRACT

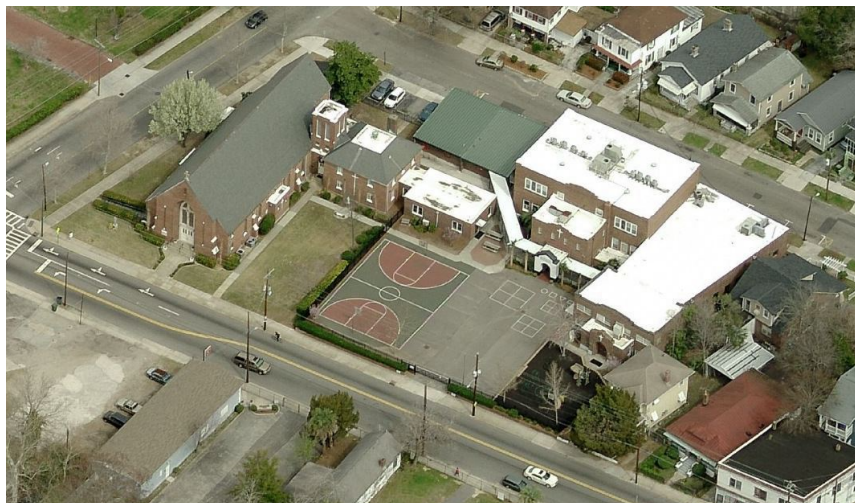
Figure 1. Sacred Heart Catholic Church and adjacent school. The church (to the left of the basketball court) consists of a sanctuary, bell tower, and rectory (from left to right).

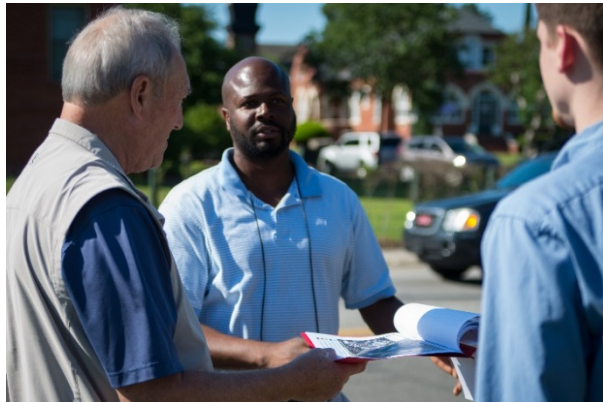
Figure 4. Students presenting findings of traffic study to adjacent (affiliated) school staff.

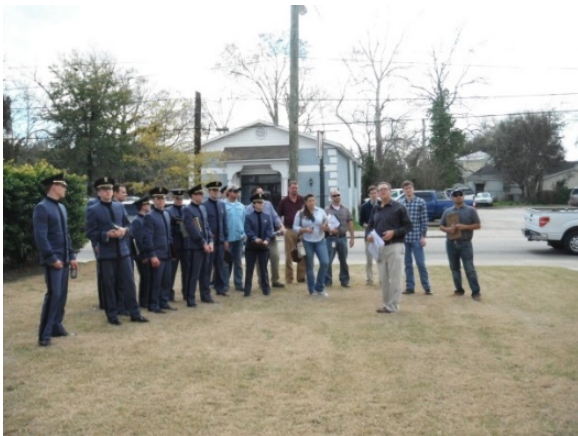
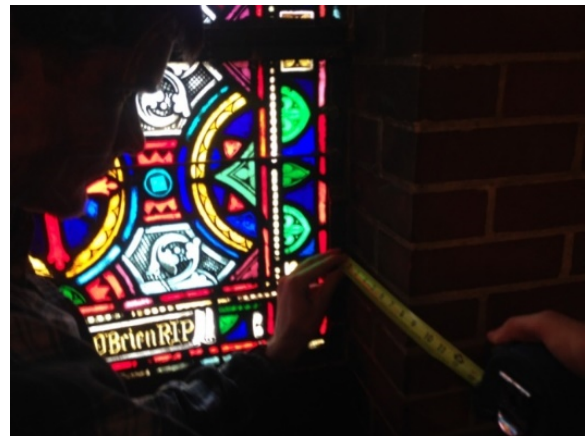
Figure 7. Students meeting with structural engineer during initial phase of the seismic assessment (left) and student verifying masonry wall thickness for seismic calculations (right).

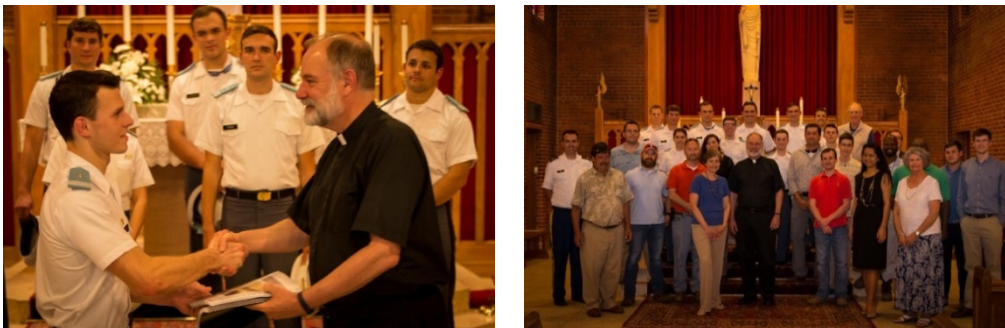
Figure 8. Students delivering final report to Sacred Heart pastor (left) and church and student participants gathered at project completion (right).
