# Seismic Assessment and Retrofit of a County Pump Station

A pump station, owned and operated by a county, is part of a flood control system for three surrounding densely populated cities. The pump station, comprising of a steel pumphouse and a reinforced concrete dam, was built in 1960's prior to seismic provisions were in place.

The county requested one of our capstone teams to perform a seismic assessment of, i) the two structures, ii) non structural elements within the pumphouse, and iii) the retaining wall which is part of the fish ladder within the system, and provide retrofit recommendations for any identified deficiencies.

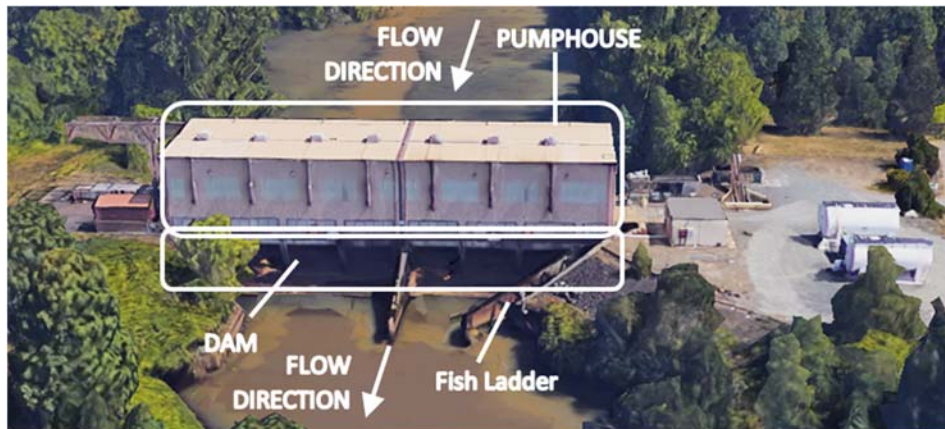
Figure 1. Bird's Eye View of Pump Station Looking Upstream (Source: Google Earth)

The Facility is located near the confluence of three major rivers and is part of a flood control system for the region. The Facility consists of a concrete dam and a steel pumphouse structure as shown in Figure 1. It spans one of the three rivers and protects three cities upstream of the Facility from flood inundation by regulating river flows and by controlling high tides from reaching the river tributaries that lie upstream of the Facility.

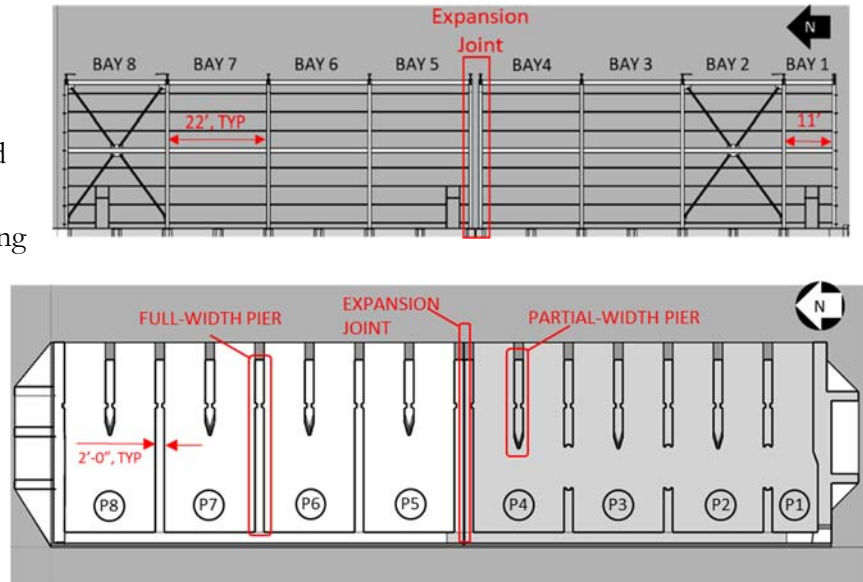
Figure 2. Plan View of Pump house (top) and Dam (bottom)

**Description of Pumphouse:** The pumphouse is a steel-framed structure with corrugated steel sheathing and has an exterior length of 165' and width of 36'-8". The roof heights are 29'-6" and 32'-6" above the operating floor on the down and upstream ends, respectively. As shown in the plan view of the pumphouse (Figure 2 - top), a transverse expansion joint separates the pumphouse into two structurally isolated sections with four bays in each section. The roof and walls of Bays 2 and 8 are braced to resist lateral (ie. seismic) forces.

**Description of Dam:** Like the pump house, the dam also consists of two monolithic reinforced concrete structures separated by a transverse expansion joint (Figure 2 - bottom). The dam rests on a 171' long x 43'-6" wide x 2' thick reinforced concrete mat foundation. The 1' thick concrete slab ceiling of the dam serves as the operating floor of the pumphouse. Each of the two dam sections has four pump bays (marked P1 to P8 in Figure 2- bottom) and the bays are separated by 40' high concrete piers, the full height of the dam. The concrete piers separating the bays, and the

The bolted connection of one of the largest pumps (P6 in Figure 2-bottom) onto the pumphouse floor was found to be the most critical non-structural member due to the large seismic mass and eccentricity between the pump and the bolted connection. The team checked the A325 steel bolt connections shown in Figure 6 and found them to be adequate with a D/C ratio of 0.02.
