# **Structural Design of Dam Sluice Gate Walkway Slabs: Retrofit and Replacement Options**

## Structural Design of Dam Sluice Gate Walkway Slabs: Retrofit and Replacement Options

A local utility company issued a Request for Proposal to our university's capstone design class for structural improvements to their dam facility. The company identified reinforced concrete service walkways at each of the dam's seven sluice gates as damaged and in need of repair or replacement. The walkways are routinely used by staff for dam maintenance, posing a life-safety issue.

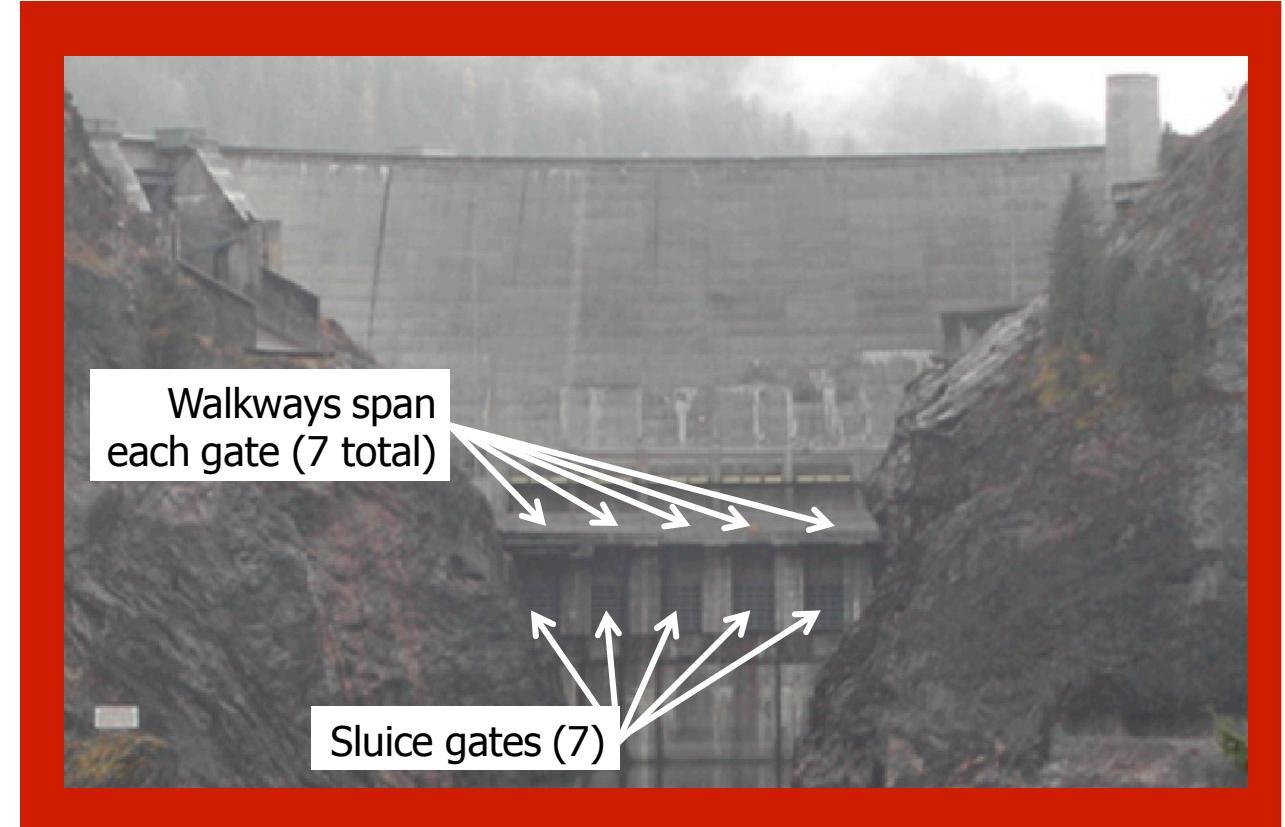
Dam with seven walkways

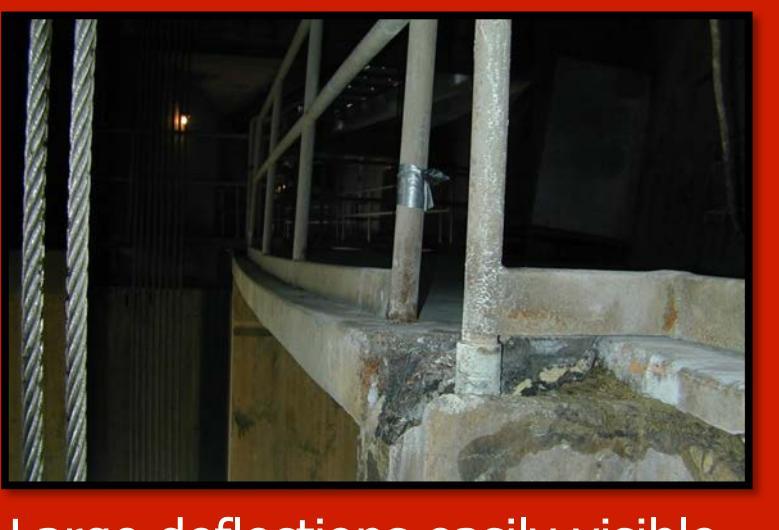
- Existing slabs overloaded
- Deflections > 2.5 in

## Large deflections easily visible

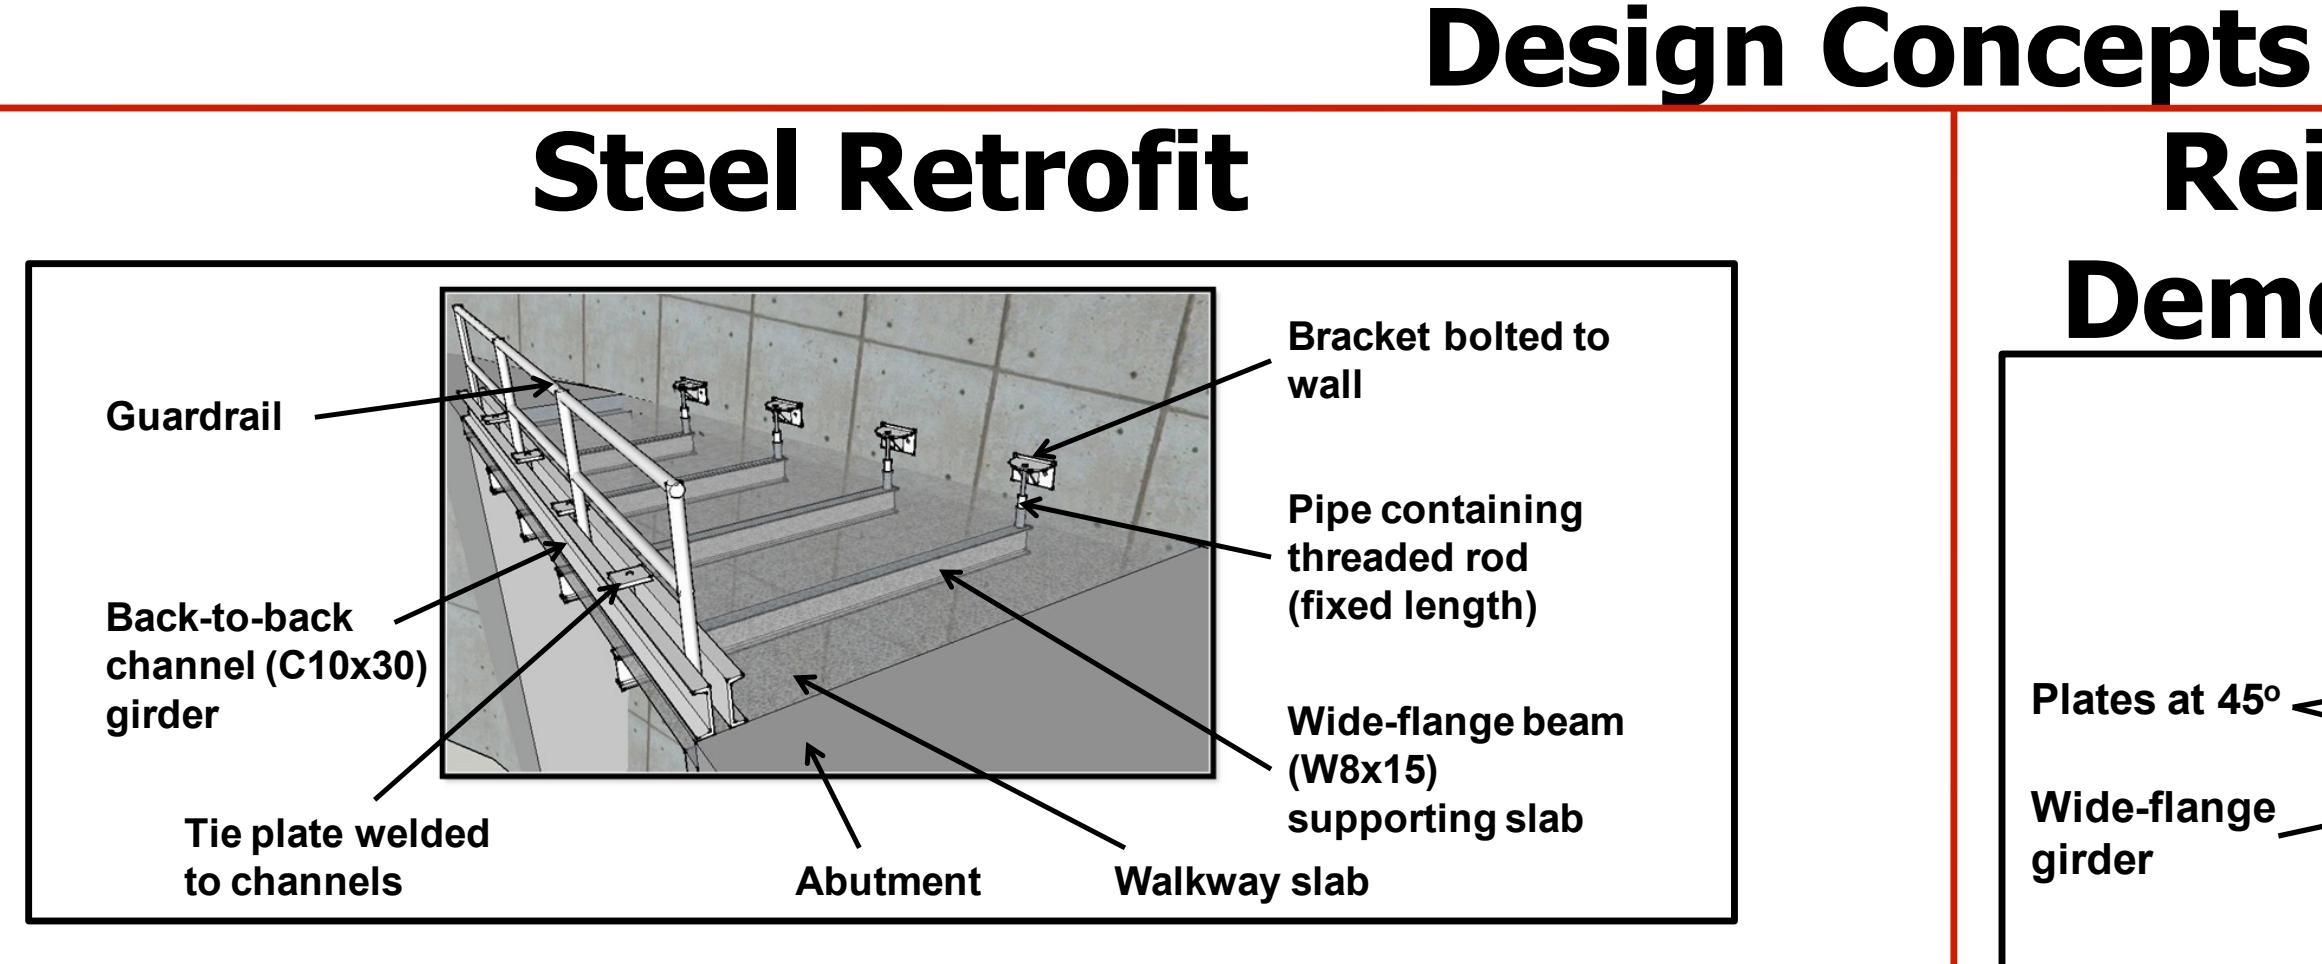
- Galvanized W8x15 beams span existing slabs
- Beams supported upstream by wall bracket, downstream by channel girder
- Threaded connections for constructability

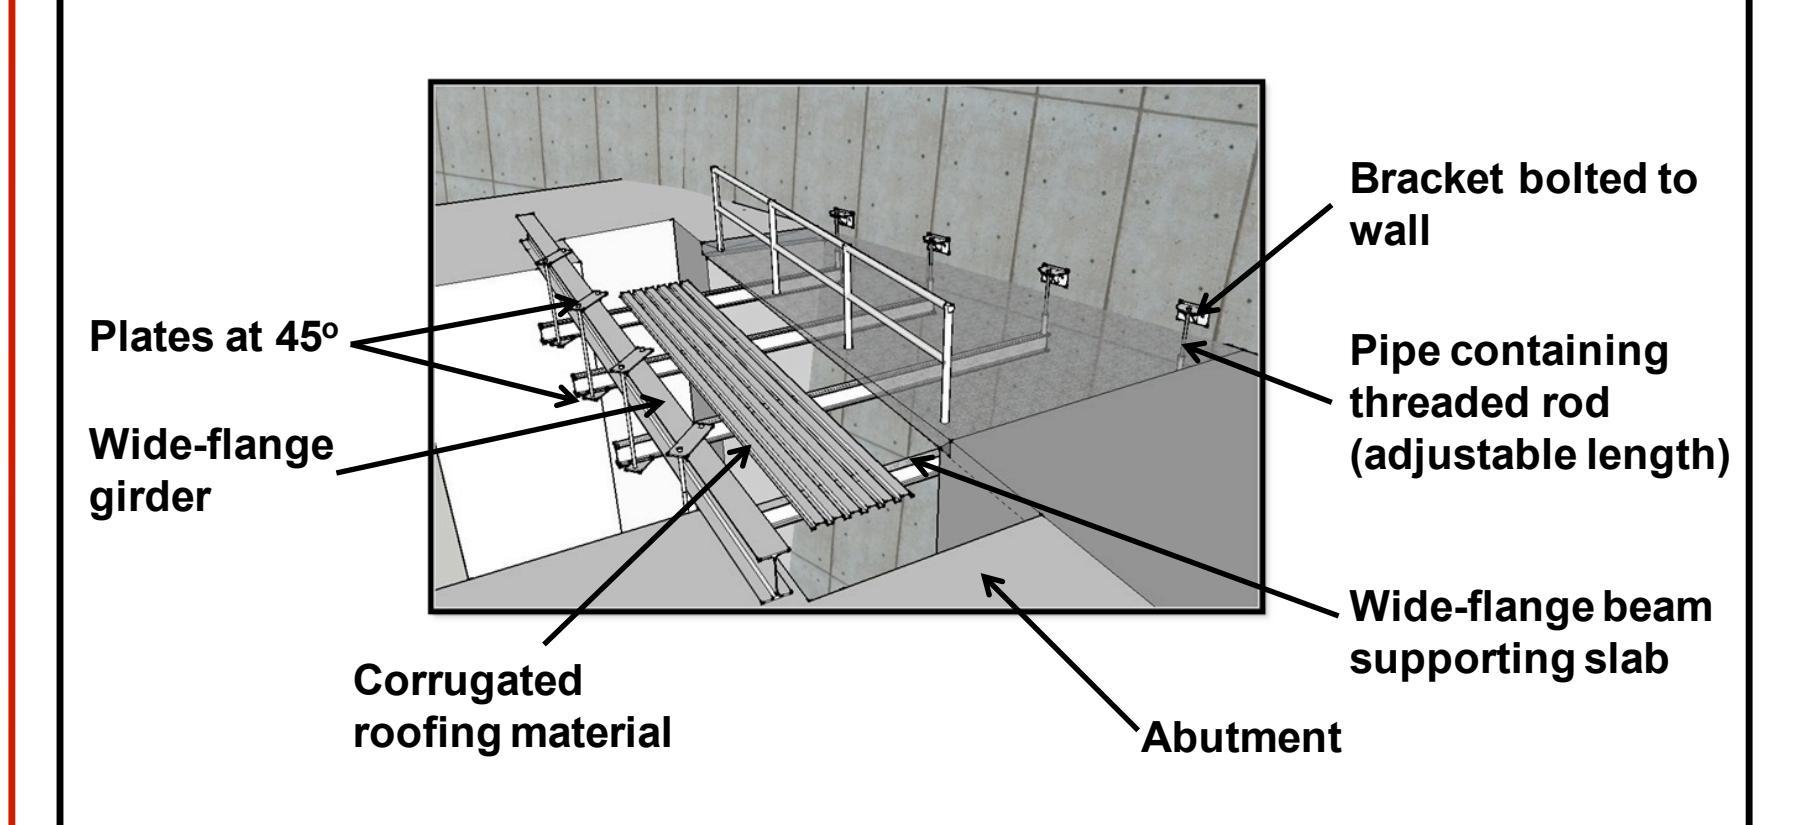
**Reinforced Concrete Slab Demolition and Replacement**

• Temporary steel shoring system

• Formwork constructed on temporary shoring and new reinforced concrete slabs cast

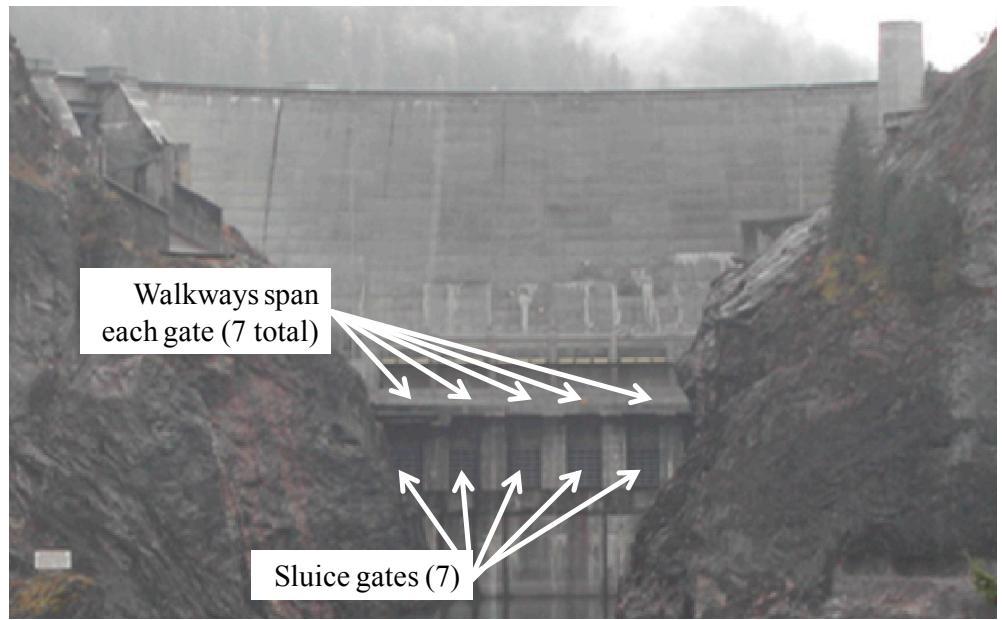
Figure 1. Dam with location of service walkways and sluice gates

A local utility company issued a Request for Proposal to our university's capstone design class for structural improvements to their dam facility. The company identified reinforced concrete service walkways at each of the dam's seven sluice gates as damaged and in need of repair or replacement. Figure 1 shows the dam with the walkways and sluice gates identified. The walkways are routinely used by staff for dam maintenance, posing a life-safety issue.

The dam was completed in 1967. An extensive design and strong bedrock foundation permitted a slender cross-section with a structure functionally similar to an eggshell. The dam is 30 feet thick at the base and tapers to only eight feet at its top, holding back a reservoir depth of over 300 feet. The facility supplies 47% of their hydroelectric generation capacity.

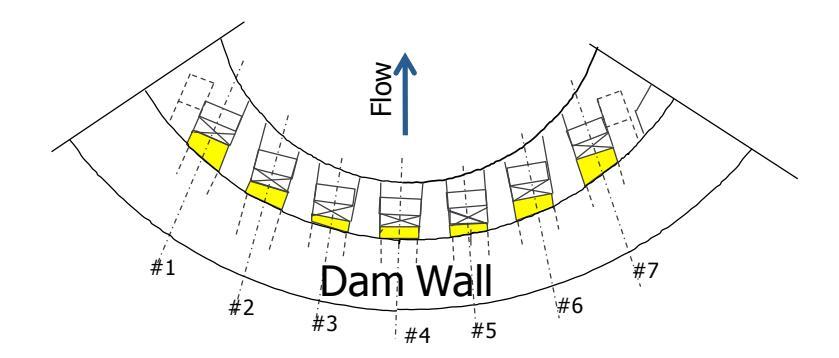
Figure 2. Plan view of seven maintenance walkways (shown in yellow) with varying geometries

Figure 2 presents a plan view of the dam, showing the seven service walkways and their unique geometries. The walkways were constructed for maintenance of the sluice gates and most commonly support loads from foot traffic as well as maintenance equipment. Each of these walkways is a doubly reinforced concrete slab spanning approximately 20 feet and supported by abutments extending from the main structure between the sluice gates.

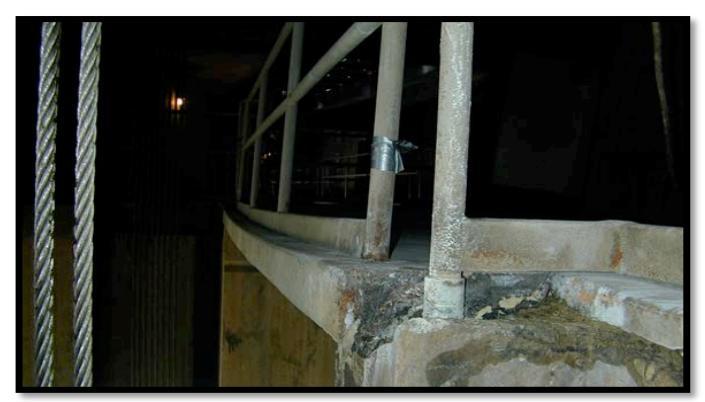
Figure 3. Existing slab deflection (measured at site visit as up to 2.5 inches)

Figure 3 presents a photograph of one of the existing walkway slabs. Deflections were measured to be as large as 2.5 inches. During previous maintenance activities, these slabs were overloaded and permanently damaged by service crews. Although crews are now more conscientious of the load capacities, the past overloading excessively deflected the slabs posing a life-safety hazard for utility workers. Consequently, the walkways need to be strengthened or replaced.

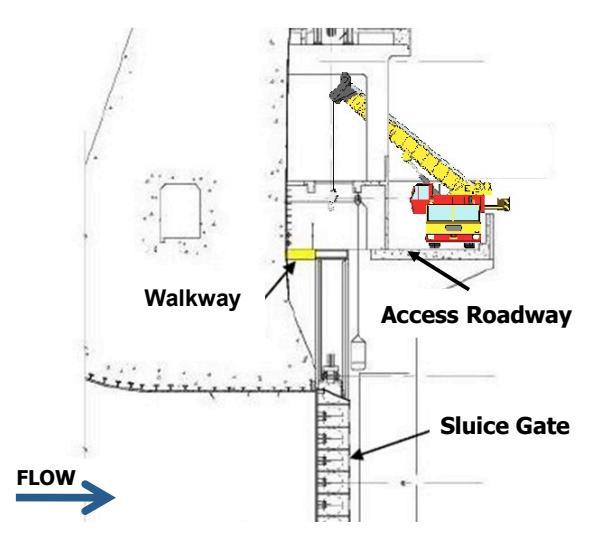
Figure 4. Typical Cross Section through Sluice Gate

trucks, concrete pumps, and the utility's crane. Figure 4 shows a typical cross section through the sluice gates. Crane access is further limited by overhead roof structures that were constructed after the installation of the original walkway. Demolition and construction plans needed to account for these restrictions.

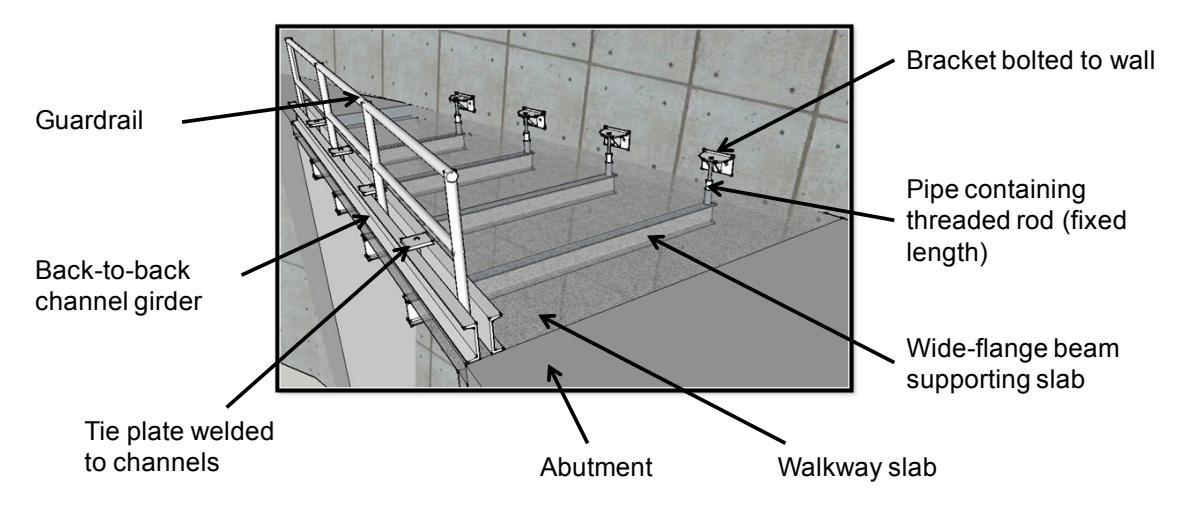
Figure 5. Completed Steel Retrofit

Figure 5 shows the steel retrofit option. Four wide-flange beams support the floor slab, satisfying the deflection requirements. The beam supports consist of a pipe welded to the top flange at each end of the beam with a threaded inlet. The pipe extends above the beam through a core hole in the slab and a threaded rod connects the pipe to the supporting element for the beam. One end of the beam is supported by a bracket bolted to the wall 12 inches above the slab. The other side does not have a wall to support connection brackets, so a girder extends across the slab perpendicular to the beam for support. The girder is as long as the slab and will transfer the load through the slab into the existing guardrail between them. A  $\frac{1}{4}$  inch plate is welded to the bottom of the channels and a one inch plate to the top of the channels. These members brace the channels together. The top plate has a  $1^{-1}/_{16}$  inch hole to accommodate the threaded rod and supports the pipe and beam.

Rebar corrosion in the existing slabs is a concern and the retrofit design assumes 100% strength (non-corroded) of 40 ksi rebar. Therefore, the design requires that the existing rebar be checked using a corrosion analysis instrument (Proceq Canin). If the rebar is not corroded, the retrofit may be carried out. If corrosion is found, the design strength of the slabs should be reduced, or if corrosion is extensive, it may be necessary to pursue the full replacement option. It is also essential to seal the cracks in the bottom of the slabs so that water will not penetrate into the cracks, consequently, into the rebar.

The steel retrofit was presented as an economical alternative to a full replacement and was expected to increase the load capacity of the existing slabs to that specified by the sponsor while limiting further deflections. The retrofit involves installing beams under the slab to reduce the span length and thus the deflection.

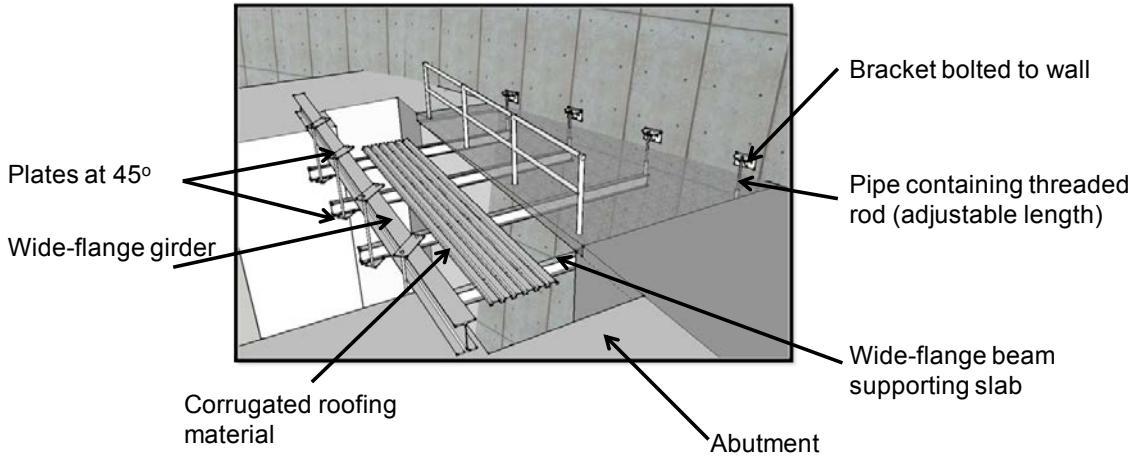
Figure 6. Completed Demolition Bracing System

Although the retrofit is the more sustainable and cost effective option, the project sponsor also requested a design for demolition and replacement of the existing slabs that guarantees a 50 year design life. Deteriorated slabs, or those damaged in the retrofit process, may be replaced using this design. Similar to the retrofit concept, demolition involves the installation of wide-flange beams under the slab. In this case, the beams serve to support the process of removal of the damaged slabs. Figure 6 shows the demolition bracing system.

The supporting beams connect to the dam wall in the same manner as described in the retrofit option. In the downstream end, a wide-flange girder rests between the abutments. The beams connect to the girder with plates on the top and bottom flanges oriented at 45°, as shown Figure 6, using threaded rods.

After the existing slabs are properly supported, the demolition process begins by elevating the corrugated metal deck support until it is snug with the bottom of the existing slab. Due to the placement of the walkways and the limited crane capacity, the slabs will be cut into pieces

weighing approximately 200 pounds to be carted away from the construction area. These cuts will be made with a diamond saw blade and the slurry will be contained with a shop-vac on site to prevent any environmental damage to the river.

The bracing system was designed for the largest slabs, to size members with the capacity to support each of the seven walkways. To keep this portion of the dam operational and save on cost, the demolition and replacement process is designed to replace one slab at a time. Construction begins with the largest slab (slabs 7 or 1) and continues around the face of the dam as the slabs cure and develop enough strength to support the design loads.
