WATER SUPPLY, DISTRIBUTION AND STORAGE

SAN PABLO DE AMALI, ECUADOR

1. *Project Description:*

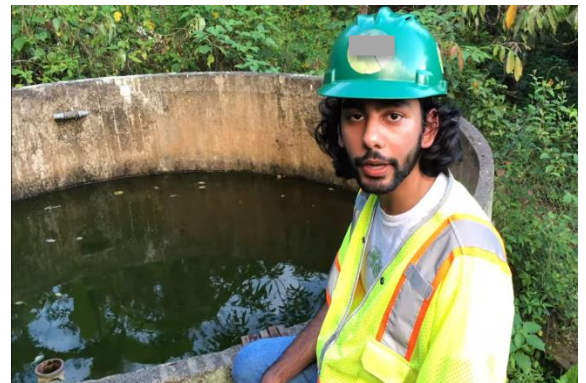
Figure 1: Nonfunctional Gravity Sand Filter

Without the proper training, skills, spare parts, materials, basic tools or funding, the community did the best with what they had to keep the system running for nearly 50 years. However, soon after the water system was commissioned, the community could not afford chlorine tablets, so the disinfection facility quickly went unused, and the community went back to boiling drinking water. In addition, the intake facility did not account for sediment transport and the filter was not designed with a backwashing feature, so the filter would routinely get clogged with sand and silt. Due to high sediment fouling of the filter, it was ultimately by-passed and decommissioned. In the early 2000's, a landslide washed out

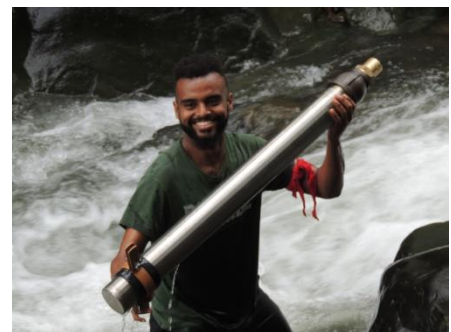
Figure 2: 300 Micron Intake Screen

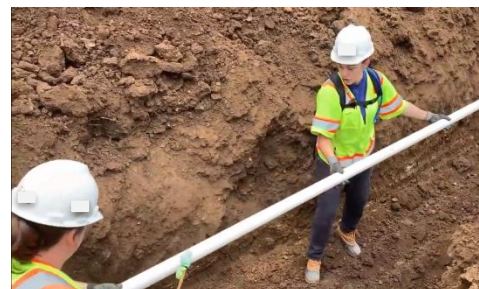
Figure 3: Installation of Distribution Piping

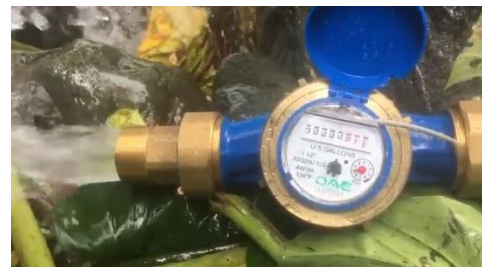
Figure 5: The new water system can provide 35-gpm of water to the community.

Mechanical and Control Systems Engineering: The students sought advice from a Professional Mechanical and Control Systems Engineer to help them understand how to control the water flow within the water distribution system. They learned and installed a hydraulically triggered float valve on the supply line to avoid the tank from being overfilled. Once the valve was installed, they calibrated the float to shut off the water supply about six inches from the top of the tank. We also learned about flow meters and why they are important.
